# Manhole Inspection Summary

Manhole # S43SS\_019MH

Insp Date: **2/27/07 10:53 AM**

**Location** Address: **2635 ROBB ST**

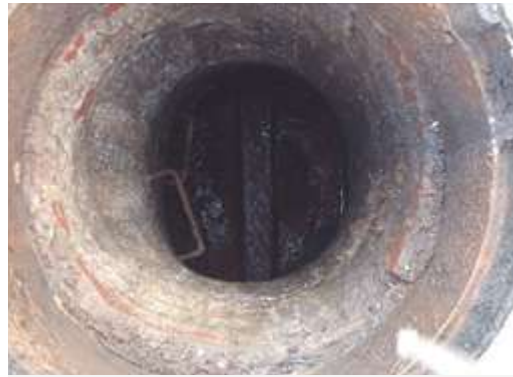
Top View

☐ Parged ☒ **Debris** (not Condition related)

**Steps** Count: **4** Missing: **1** ☒ **Corroded**

**Surcharge** ☒ **Evidence Of Surcharge** Depth: **1.5** (ft.) ☐ Active Surcharge Present

Corroded and missing steps. Evidence of surcharge - Bench debris.

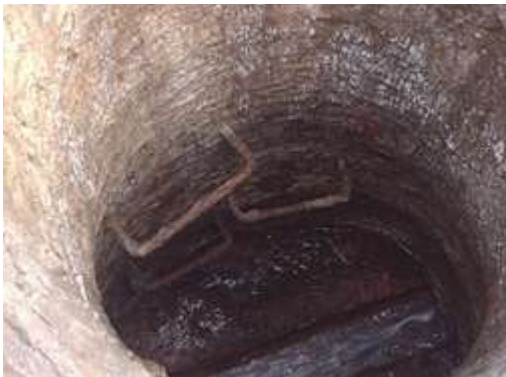
Defect

Infiltration: ☐ None ☐ Joint ☐ Cracks ☐ Mortar ☐ Roots ☒ **Wall**

Barrel infiltration.

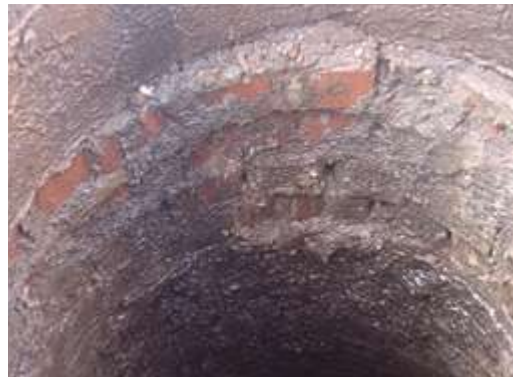
Defect

**Frame** Offset: **2** (in.)

☒ **Leaks**

Condition: ☐ Sound ☐ Cracked ☐ Root Intrusion ☐ Loose Brick ☒ **Deteriorated**

Infiltration: ☐ None ☒ **Joint** ☐ Cracks ☐ Mortar ☐ Roots ☒ **Wall**

Infiltration: ☐ None ☐ Joint ☐ Cracks ☒ **Mortar** ☐ Roots ☒ **Wall**

Frame leaks. Frame offset. Adjustment and Corbel deterioration and infiltration.

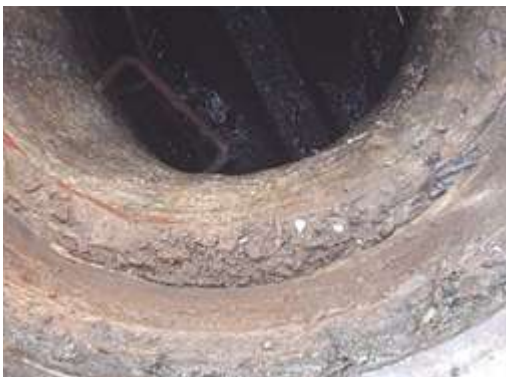
Defect

Frame leaks. Frame offset. Adjustment deterioration and infiltration.

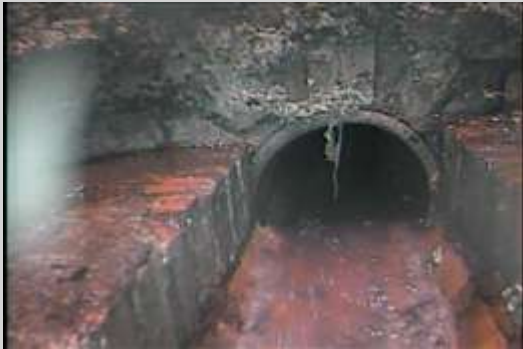
### 8 in. Circular Gravity Sewer Pipe Out @ 12 O'Clock

Infiltration: **None** Pipe Seal Cond: **Roots**

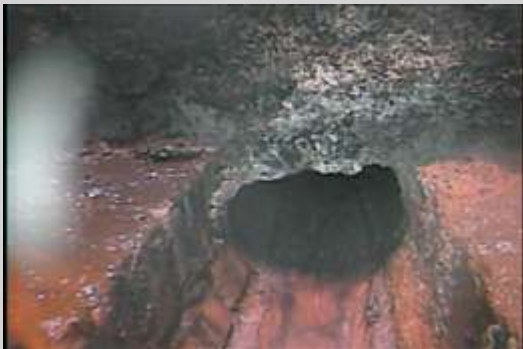
### 8 in. Circular Gravity Sewer Pipe In @ 6 O'Clock

Condition: ☐ Sound ☐ Cracked ☐ Root Intrusion ☒ **Deteriorated** ☐ Leaks ☐ Debris

Channel deterioration.
